# LAWRENCE TECHNOLOGICAL UNIVERSITY

## INSPECTION AND DETERIORATION OF BRIDGE DECKS CONSTRUCTED USING STAY-IN-PLACE METAL FORMS AND EPOXY-COATED REINFORCEMENT

Testing and Research Section  
Construction and Technology Division  
Contract # 2002-0134

**October, 2004**

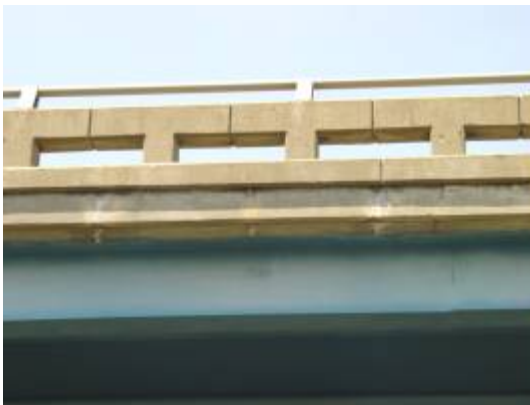
Cracks were found at the top surface of the road and the curbs as shown in Figure 3.6. The cracks propagated longitudinally, transversely, and diagonally along the entire length of the bridge. The cracks were found at the sides of the deck slabs as shown in Figure 3.7. A different type of concrete (as indicated by the difference in color) was encountered at the sides of the joints in the top surface (Figure 3.8).

Figure 3.7. Cracks propagated through the sides

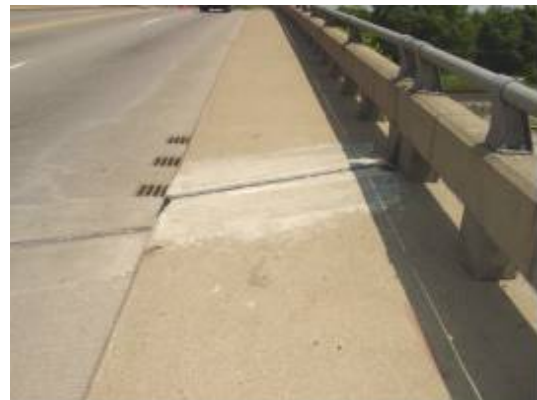
Figure 3.8. Different types of concrete around the joints

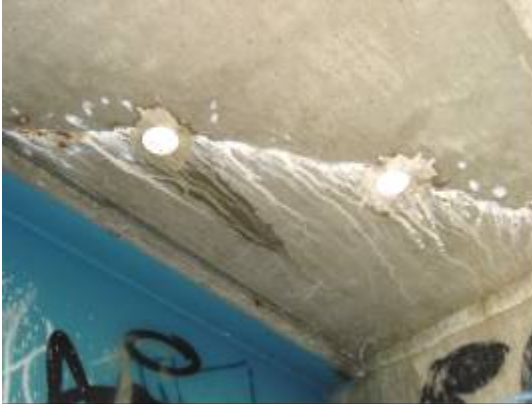
The bottom surface of the deck slab had cracks propagated transversely, longitudinally and diagonally (Figures 3.9 a, b and c). A thick layer of light colored material filled the cracks and spread in the direction of the bridge slope (Figure 3.9d). Some of the cracks also had corrosion traces. The drainage holes had corrossions in the deck without SIPMF (Figure 3.9e).

a. Diagonal cracks with white traces

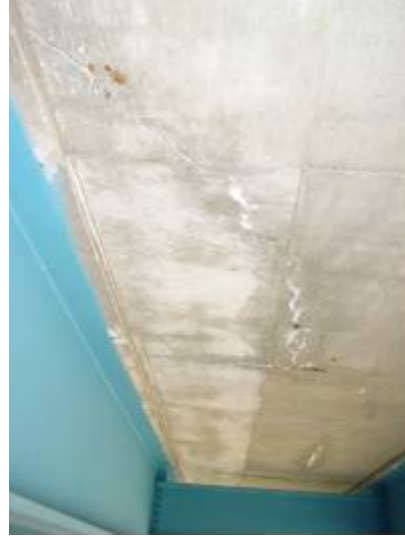
b. Longitudinal cracks with white traces

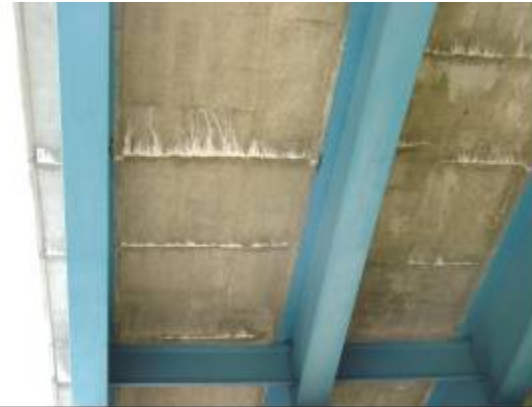
c. Transverse cracks with white traces

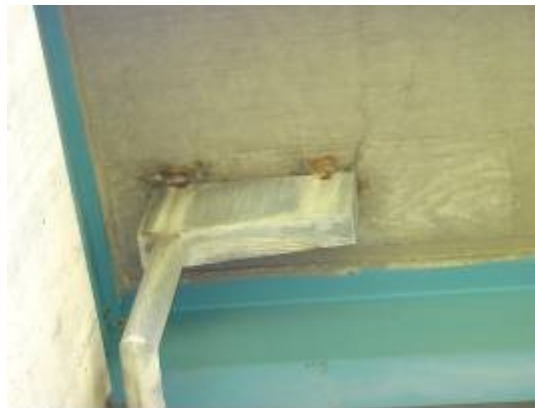
e. Rust traces from reinforcement around the drainage holes

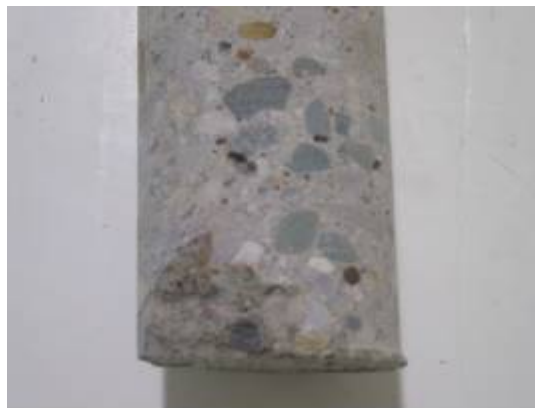
#### **Core 1a** (Figure 3.11)

- 10.0 in. height.
- Part of the edge of the core at the bottom was fractured during the coring.
- Two locations of honeycombing of approximate length of 0.3 in. were encountered at 2.5 in. and 3.0 in. from the bottom.
- Large voids of average diameter of 0.2 in. were located 3.0, 4.5, 5.0, and 6.2 in. from the bottom.

Figure 3.11. Core 1a shows large region of honeycombing

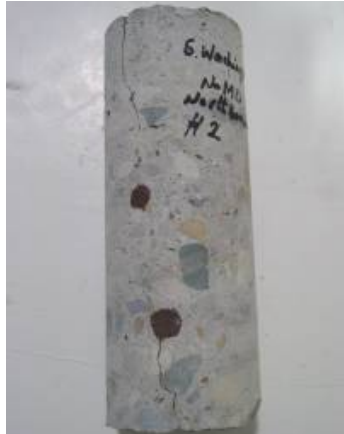
- 10.0 in. height.
- A crack of average width of 0.05 in. extends the entire length of the core.
- Four axial cuts in the reinforcement were present at 4.5 and 7.5 in. from the top.
- The exposed reinforcement showed severe signs of rust.
- A large region containing honeycombing of approximate width 0.4 in. was located 5.2 in. from the top.

Figure 3.13. Core 1b  
longitudinal crack

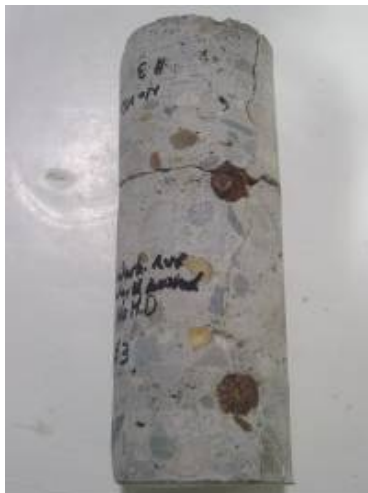
- 10.0 in. height.
- The core was cracked and split by a lateral crack at the location of the reinforcement at 4.0 in. from top.
- A crack of average width of 0.05 in. extends the entire length of the core.
- Four axial cuts in the reinforcement showed severe signs of rust.
- Part of the edge of the bottom of the core was fractured during coring.
- Two locations of honeycombing of average width of 0.3 in. located 2.5 in. and 5.0 in. from top.
- Two large voids of average diameter of 0.3 in. were located 7.0 in. and 8.0 in. from top.

Figure 3.15. Core 1c rust in steel

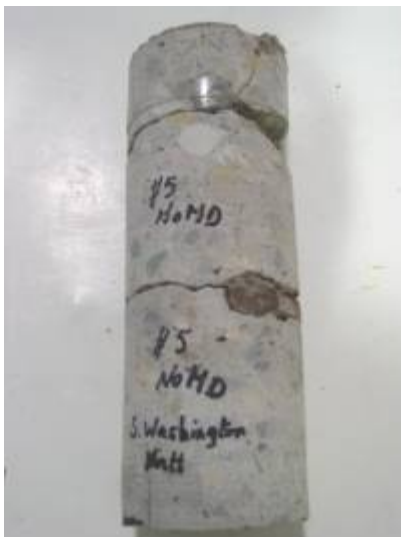
- 10.2 in. height.
- The core was cracked and split into three segments by two lateral cracks; both at the locations of the reinforcement. The cracks are located 4.5 in. and 8.3 in. from the top.
- Two longitudinal cuts in the reinforcement located 4.5 in. and 8.3 in. from the top.
- The exposed reinforcement showed severe signs of rust.
- Part of the concrete was fractured at the crack located 8.3 in. from the top.
- A crack of average width of 0.03 in. width propagated along the entire depth of the core.
- Two large voids of average diameter of 0.3 in. located 5.8 in. and 7.8 in. from the top.

Figure 3.17. Core 1e cracks at the reinforcement bars

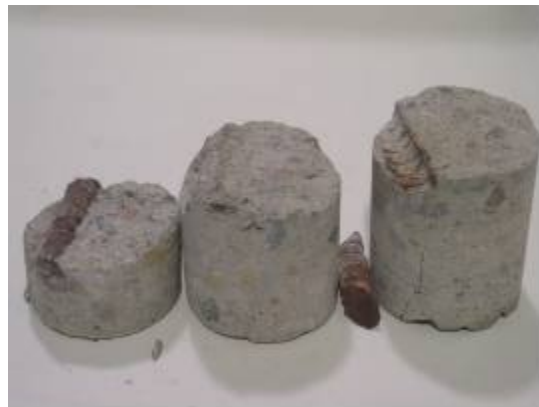
Figure 3.18. Core 1e rust in the reinforcement bar

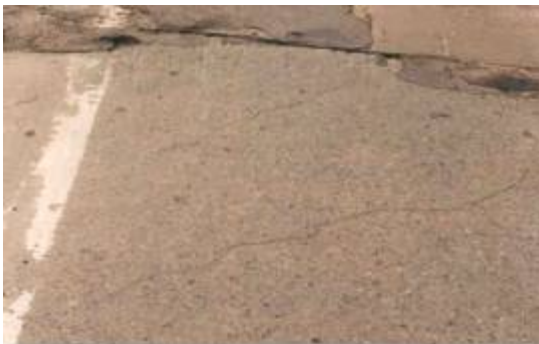
a. Diagonal cracks

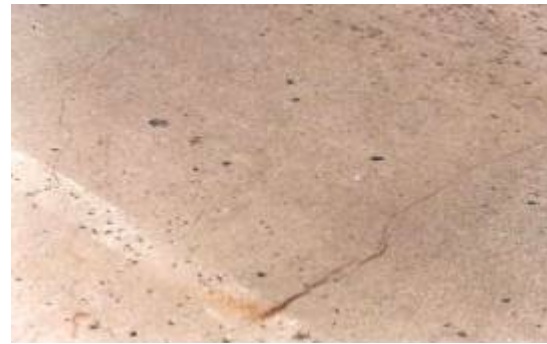
b. Transverse cracks with rust traces

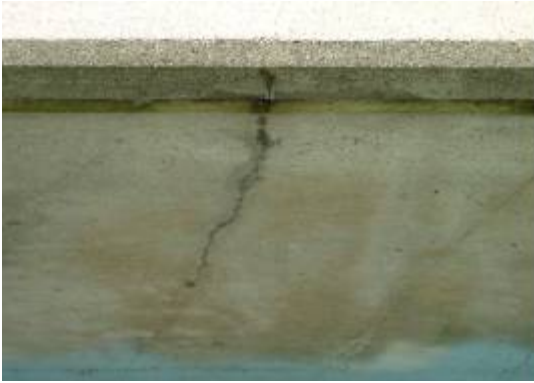
Figure 3.24. Cracks through the slab thickness

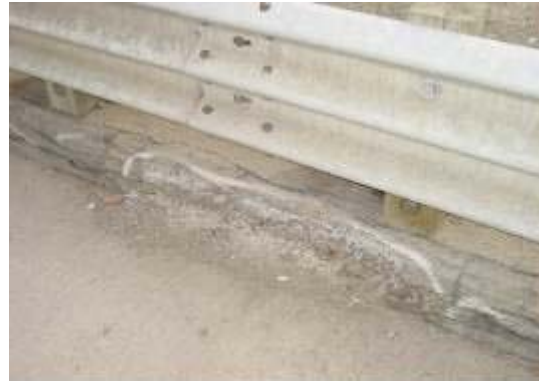
Figure 3.25. Severe deterioration of the curb

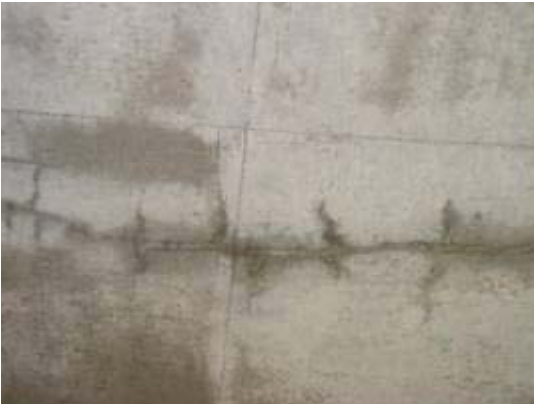
a. Longitudinal crack

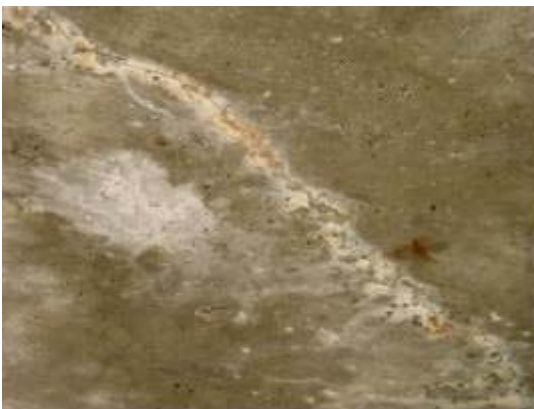
Figure 3.27. White traces on the bottom surface

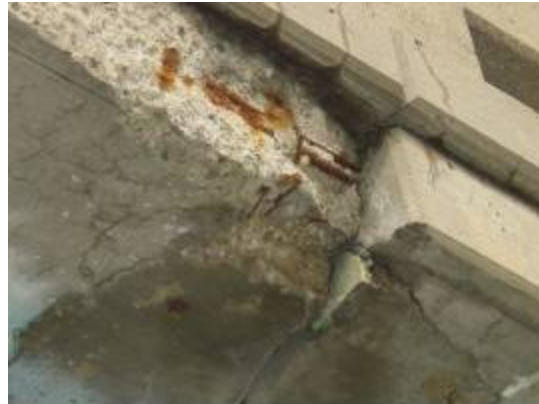
Figure 3.30. Deterioration of the concrete cover and rust traces at the joint

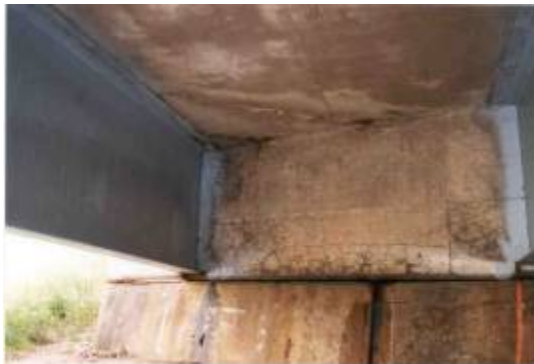
a. Water leakage

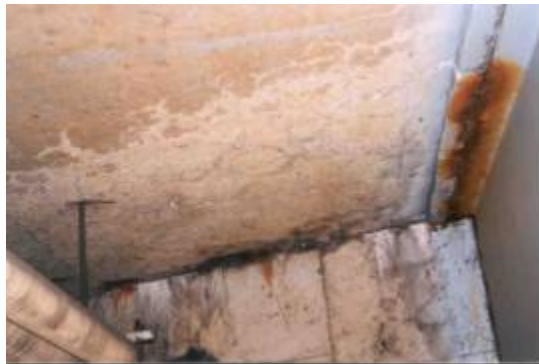
b. Cracks and rust traces

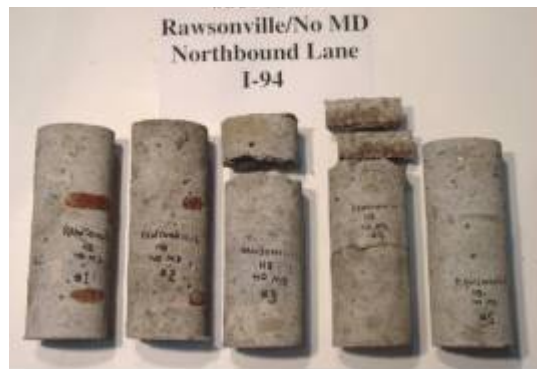
The visual inspection of cores from Bridge Deck Number 2 indicated that the bridge had no separate wearing surface at the top surface and the top surface of all cores had a grooved texture. The steel reinforcement was not coated and had traces of rust. Many voids were encountered with an average diameter of 0.3 in. The coarse aggregate was well bonded to the concrete. The cement paste had high porosity. Slag as well as conventional aggregates were used in the deck slab. All of the cores had approximately the same height of average  $9.8 \pm 0.3$  in. The five cores that were taken are shown in Figure 3.32.

Figure 3.32. The 5 cores taken from Bridge Deck Number 2 (Structure No. S03-81041)

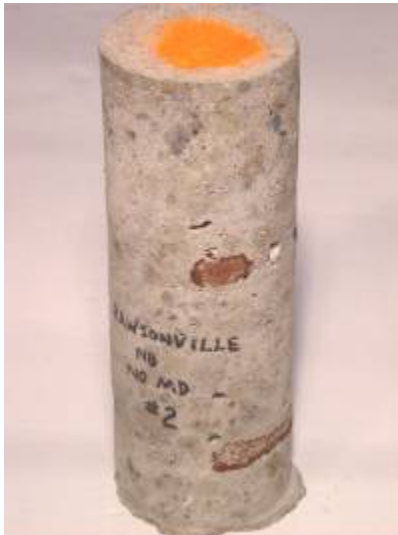
Figure 3.35. Core 2b

- 10.0 in. height.
- Slag as well as conventional aggregates were used; and cement paste had high porosity.
- Four locations of honeycombing present with average width of 0.5 in. and located approximately 3.5 in. from the top.
- Two axial cuts in the reinforcement bars located 4.5 in. from the top.

- One longitudinal cut in the reinforcement bars located 8.5 in. from the top.
- The exposed reinforcement bars showed traces of rust.

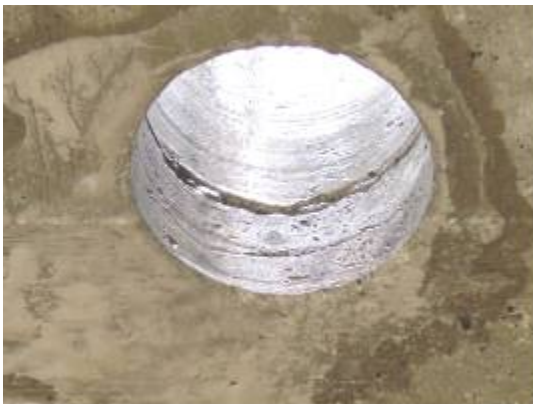
- 9.8 in. height.
- Slag as well as conventional aggregates was used; and cement paste had high porosity.
- Core was broken at 8.0 in. from the top surface due to crack existing horizontally in the slab thickness. The existing crack is shown in Figure 3.40.
- Two locations of honeycombing with average width of 0.4 in. were located approximately 1 in. and 6.8 in. from the top.

Figure 3.37. Crack in the thickness of the slab (Core 2c location)

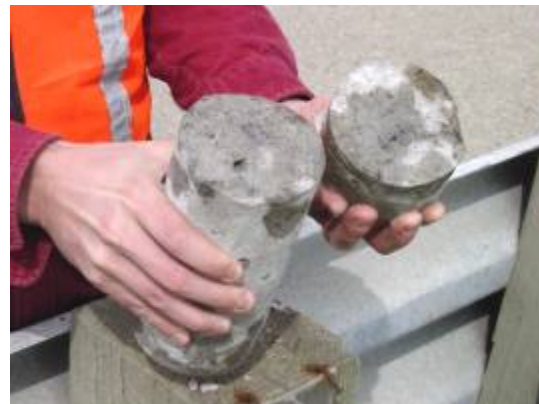
Figure 3.38. Presence of horizontal crack in Core 2c

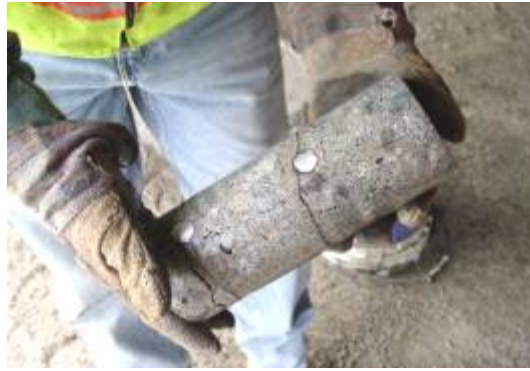
- 9.8 in. height.
- Slag as well as conventional aggregates were used; and cement paste had high porosity.
- Core was broken at 8.0 in. from the top surface at the location of the steel reinforcement bar.
- The exposed steel bar at the fracture location showed severe signs of rust and concrete deterioration.
- Four axial cuts in the reinforcement bars located 3.8 in. and 8.0 in. from the top.
- Horizontal fracture plane in the core located 4.5 in. from the top. The crack width is approximately 0.08 in.
- One hairline crack propagated along the entire length of the core and through the surface.

Figure 3.42. Core 2d after collecting it

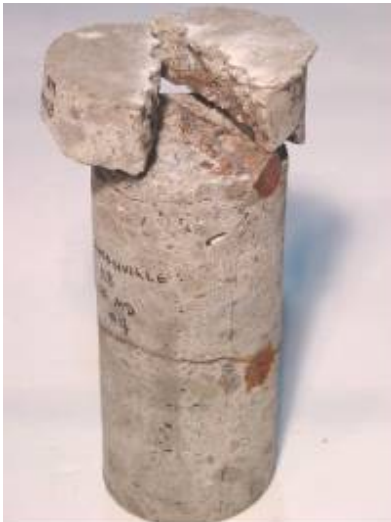
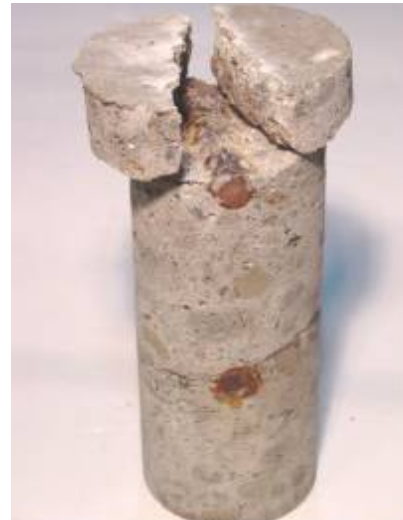
a. Core was broken at the bottom

b. Reinforcement bars are rusted

Figure 3.43. Deterioration of Core 2d

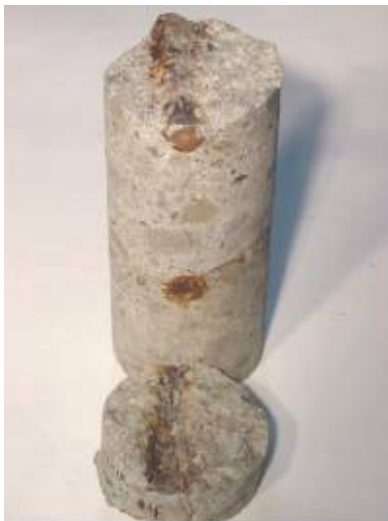
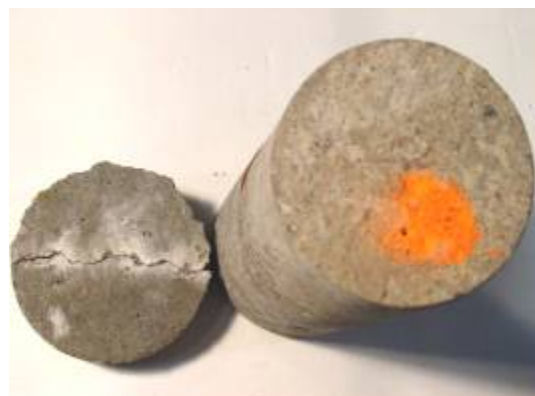
a. Rust traces

b. White traces on the bottom surface

Figure 3.44. Deterioration of Core 2d

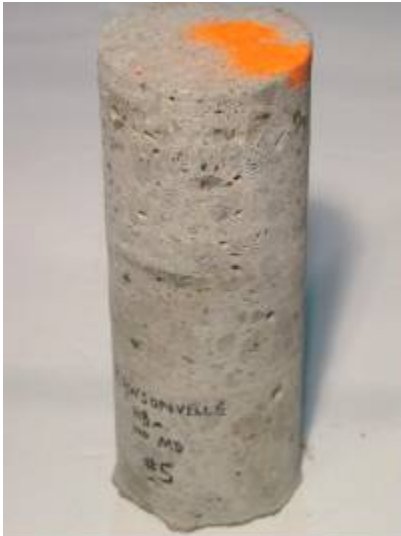
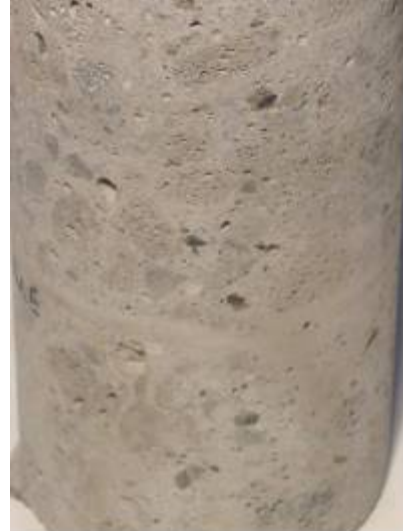
- 9.5 in. height.
- Slag as well as conventional aggregates were used; and cement paste had high porosity.
- Many large voids of 0.4 in. average diameter located 3.8 in., 5.0 in. and 6.8 in. from the top.

a. High porosity

b. Large voids

Figure 3.45. Core 2e

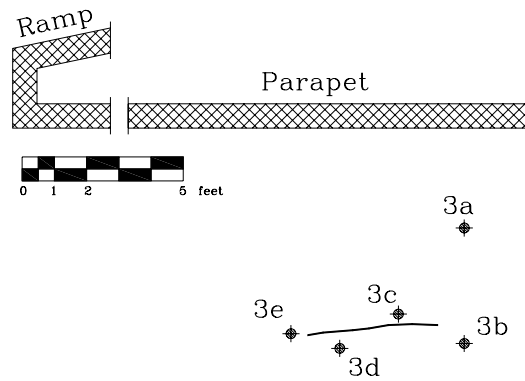
Detail 3

Figure 3.49. Map of cracks at coring locations for Bridge Deck Number 3 (Structure No. B01-82194)

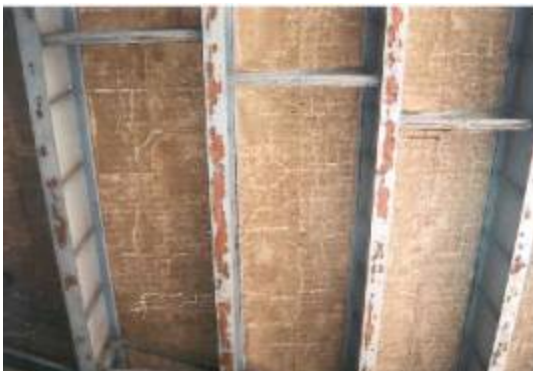
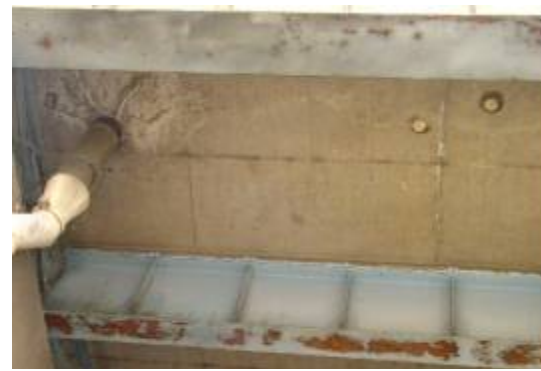
An inspection of the bridge was conducted for the top and bottom surfaces of the deck slab, steel beams and piers. Cracks were observed at the top surface of the concrete slabs (Figure 3.50). Cracks propagated transversely and longitudinally dividing the surface into small rectangles (approximately one square foot each) as shown in Figure 3.51. White and rust traces were encountered underneath the concrete slab (Figure 3.51). White traces were also encountered around the drainage pipe at the bottom surface (Figure 3.51). In some locations, the concrete cover was deteriorated and the steel reinforcement bars were exposed and rusted (Figure 3.52). The bottom surface of the cantilever deck slabs had white traces and the reinforcement bars had corrosion traces (Figure 3.53).

c. Cracks and white traces (small rectangles)

d. White traces around drainage opening

Figure 3.51. Cracks and white traces propagated on the bottom surface of the slab

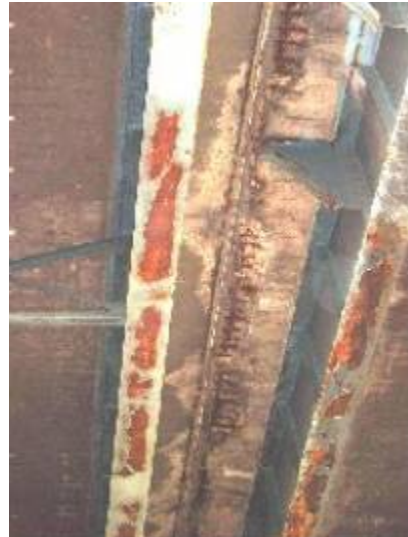
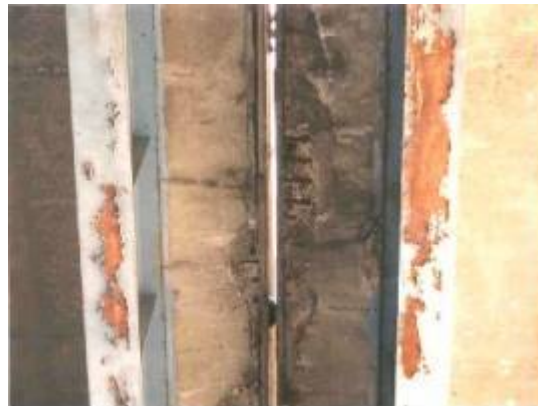
b. Rust and white traces

c. Rust and white traces

Figure 3.53. White and rust traces at the bottom surface of the cantilever slabs

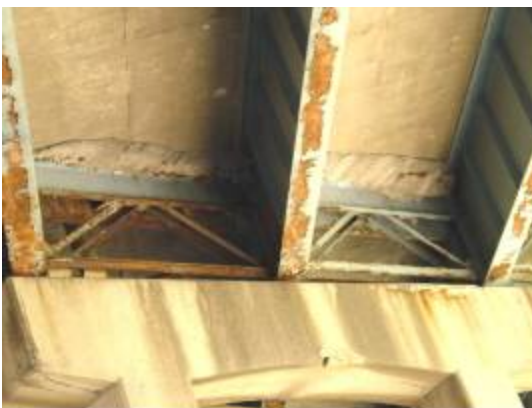
a. Deteriorated concrete cover

Figure 3.54. Deterioration at the bottom surface of deck slabs

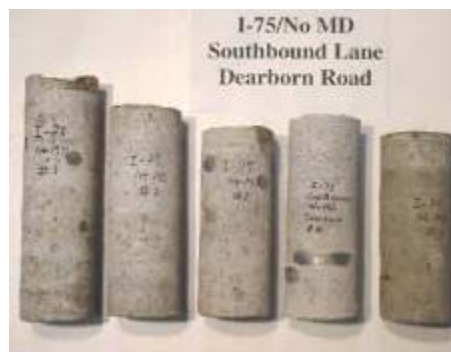
The visual inspection of cores from Bridge Deck Number 3 indicated that all of the cores except for two cores had no separate wearing surface at the top surface. The top surface was grooved for all of the cores. The steel reinforcement was not epoxy-coated and some of the reinforcement had traces of rust. No regions containing high porosity were observed. Slag as well as conventional aggregates were used. The coarse aggregate was well bonded to the concrete. The heights of the cores varied from 9.3 to 12.3 in. indicating non-uniformity of the bridge deck thickness. Five cores were taken from the concrete deck slab without SIPMF. The cores are shown in Figure 3.55.

Figure 3.55. The 5 cores that were taken from Bridge Deck Number 3 (Structure No. B01-82194)

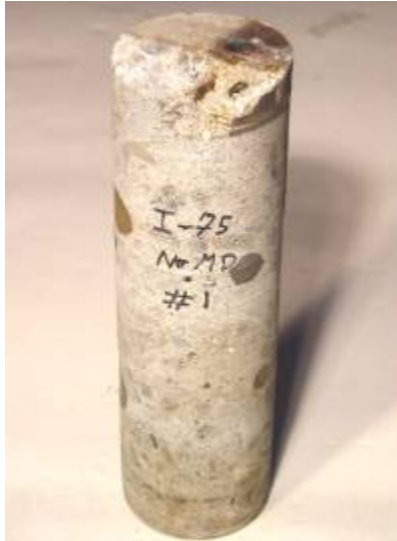
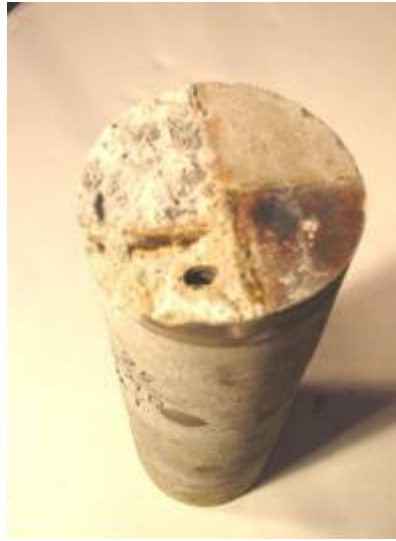
- 12.3 in. height.
- Part of the connection between the steel beam and the slab was cut and there were traces of corrosion on it.
- Six axial cuts located 4.8, 8.0 and 9.0 in. from top.
- One longitudinal cut located 3.8 in. from top.
- Five locations of honeycombing of average diameter of 0.2 in. located 5.0, 5.5, 6.0 and 8.0 in. from top.
- There was a large void of diameter 0.4 in. and depth of 3.5 in. located the bottom of the core at the location of the connection with the steel beam.
- Slag as well as conventional aggregates were used.

a. Broken bottom

b. Large void and rust at the bottom

Figure 3.56. Core 3a

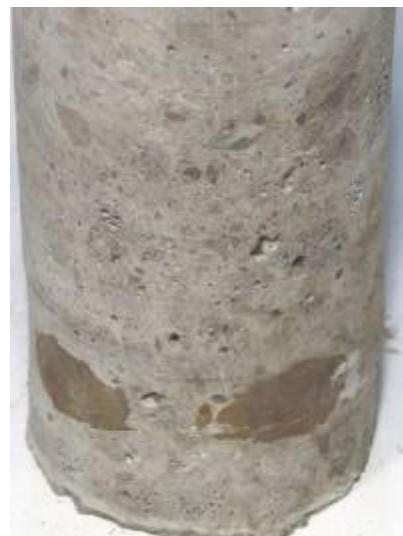
- 10.5 in. height.
- Two longitudinal cuts in the reinforcement bars located 2.0 in. from top.
- Many entrapped air voids of average diameter 0.3 in. were observed along the length of the core.
- Slag as well as conventional aggregates were used.
- Traces of rust were observed on the exposed steel reinforcement.

Figure 3.58. Core 3b voids and rust in the reinforcement

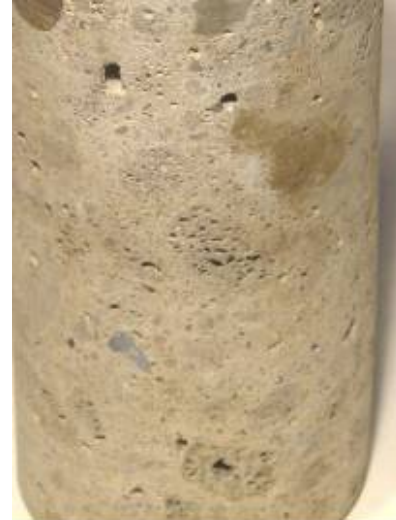
- 9.3 in. height.
- Slag as well as conventional aggregates were used; and cement paste had high porosity.
- Four axial cut in the reinforcement located 7.0 and 7.8 in. from the top.
- Three large voids of average diameter 0.4 in. located 2.8 and 6.0 in. from top.
- Steel reinforcement had rust traces.

Figure 3.60. Core 3c high porosity

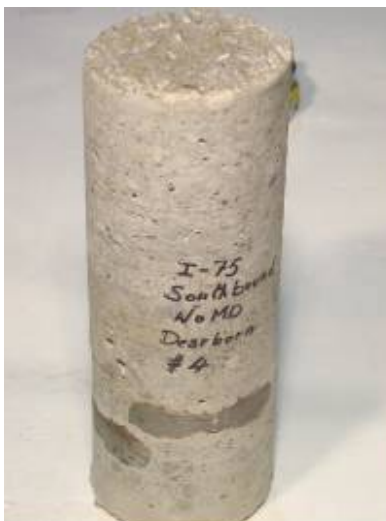
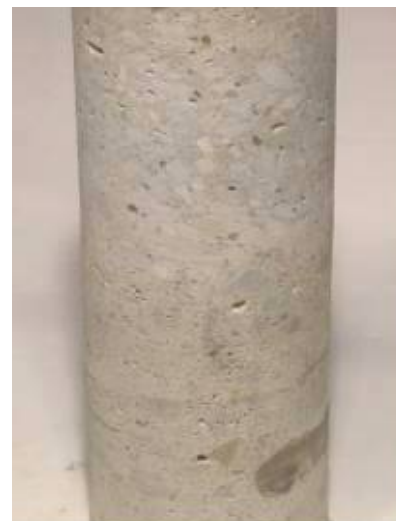
- 10.0 in. height.
- The core showed that it was cast in two different layers of concrete: an interface existed 4.0 in. from top.
- Slag as well as conventional aggregates were used.
- Two longitudinal cuts in the reinforcement were observed at 7.3 and 8.0 in. from the top.
- Many voids of average diameter 0.2 in. were distributed along the length of the core.
- Three regions containing honeycombing existed at 1.5, 5.8 and 6.0 in. from top.
- Steel reinforcement bars had traces of rust.
- One large void (0.3 in. diameter) was present 1.3 in. from top.

Figure 3.61. Core 3d

Figure 3.62. Core 3d wearing surface

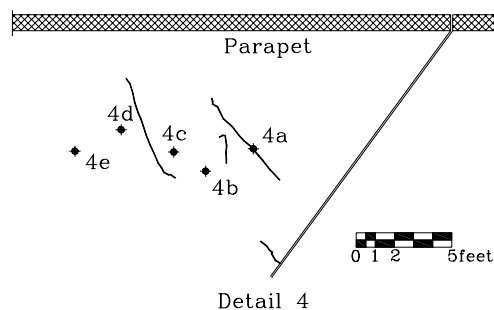
Figure 3.70. Map of cracks at coring location for Bridge Deck Number 4 (Structure No. S11-82022)

The top and bottom surfaces of the deck and beams were visually inspected. Cracks were observed at the top and bottom surfaces of the concrete slab and white traces were observed at the side of beams of the bridge. The cracks and white traces were minor and randomly propagated. The concrete condition generally appeared good.

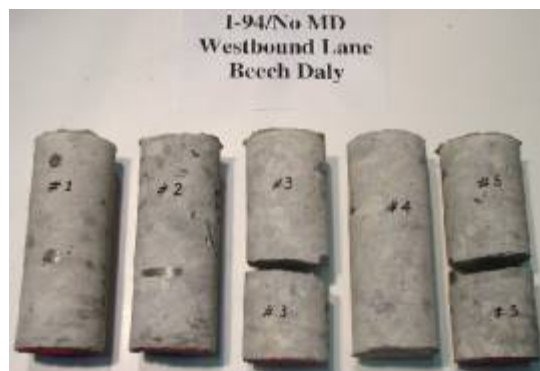
The visual inspection of cores from Bridge Deck Number 4 indicated that the concrete was placed at once, as there were no signs of a separate wearing surface. The steel appeared in excellent condition and was coated with green epoxy that was also in excellent condition. However, two cores were cracked at the reinforcement location and the steel had no traces of concrete adhering to it. The coarse aggregate was well bonded to the concrete and no regions of high porosity were observed; however, numerous entrapped air voids were observed. All of the cores had approximately the same height of average  $9.8 \pm 0.2$  in. which indicates bridge uniformity. The five cores are shown in Figure 3.72.

Figure 3.72. The 5 cores that were taken from Bridge Deck Number 4 (Structure No. S11-82022)

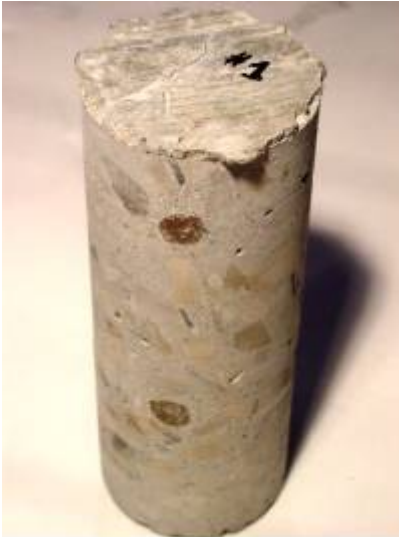
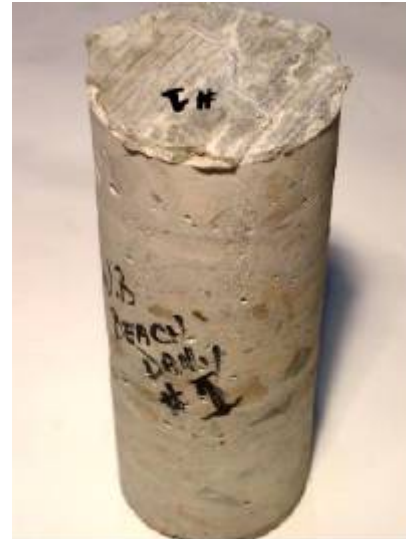
- 9.8 in. height.
- A full depth crack propagated all through the height and cross section of the core.
- Steel bars were observed at 4 in. and 8 in. from the top.

a. Reinforcement bars

b. Crack propagated through the height

Figure 3.73. Two sides of Core 4a showing a crack all along the depth of the core

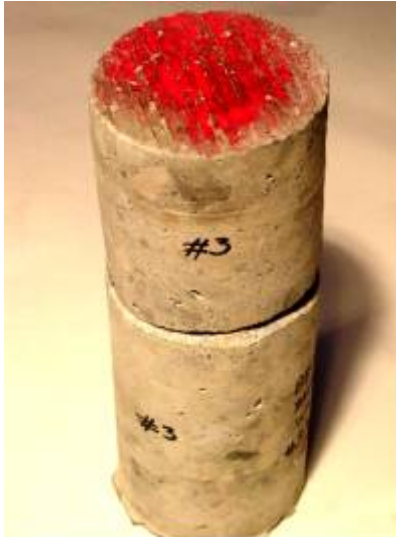
- 9.8 in. height.
- Core fractured at the reinforcement located 3.8 in. from the top.
- Numerous voids of approximately 0.1 in. diameter.

Figure 3.75. Core 4c fractured at the reinforcement location

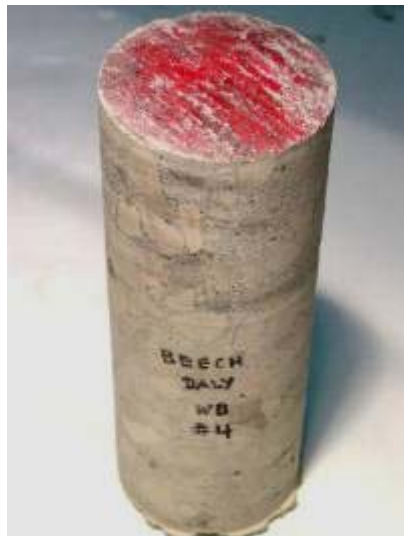
Figure 3.76. Core 4d

- 9.9 in. height.
- Overall, good concrete quality.

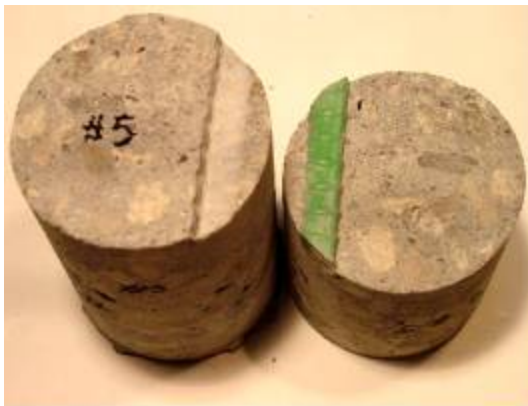
- 9.6 in. height.
- Core fractured at the reinforcement located 4 in. from the top.
- Core appeared more porous than the other cores from this bridge deck.
- Numerous entrapped air voids with an average diameter of 0.15 in. were observed.

Figure 3.77. Exposed reinforcement where core fractured in Core 4e

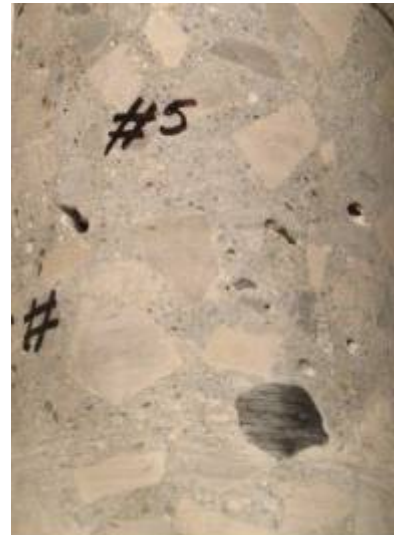
Figure 3.78. Voids observed in Core 4e

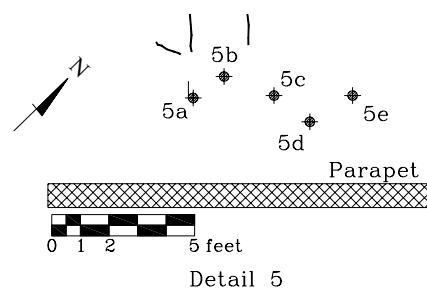
Figure 3.82. Map of cracks at coring locations for Bridge Deck Number 5 (Structure No. S09-82022)

Cracks were observed at the top surface of the concrete slab. White traces were observed underneath the concrete slab at approximately 4 ft. intervals as shown in Figures 3.83 and 3.84.

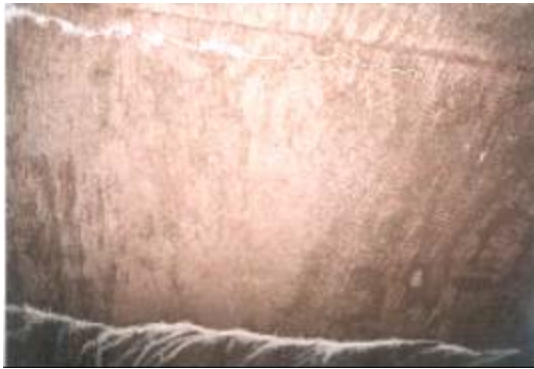
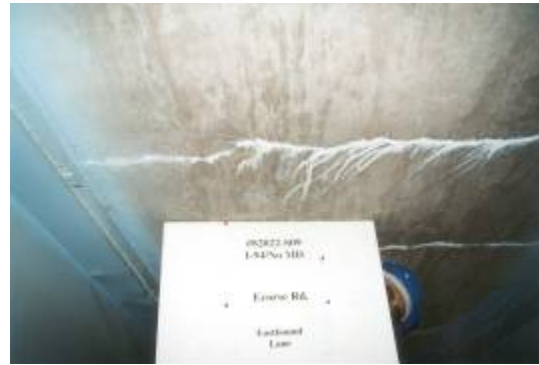
Figure 3.83. White traces at the bottom surface of the deck

a. White traces at approximately 4 ft

b. White traces with transverse crack

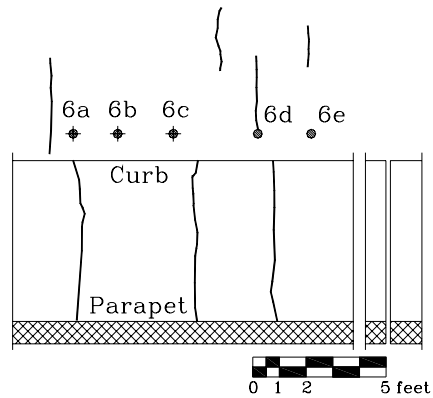
Figure 3.95. Map of cracks at coring locations for Bridge Deck Number 6 (Structure No. R01-13012)

An inspection of the bridge was conducted for the top and bottom surfaces of the deck slab, steel beams, piers and abutments. The cracks propagated longitudinally, transversely or diagonally through the bridge. Some of the top surface cracks were accompanied by corrosion of the SIPMF indicating that these cracks were full depth cracks as shown in Figures 3.96 and 3.97. A different type of concrete (as indicated by a difference in color) was encountered at the sides of the joints in the top surface (Figure 3.98). The SIPMF at bottom surface of the deck slab was corroded diagonally and transversely at the same location of the top cracks (Figure 3.99). The connections between the SIPMF and the steel beams showed rust accompanied with white traces as shown in Figure 3.100. The drainage holes had corrosions in the deck with SIPMF (Figure 3.101)

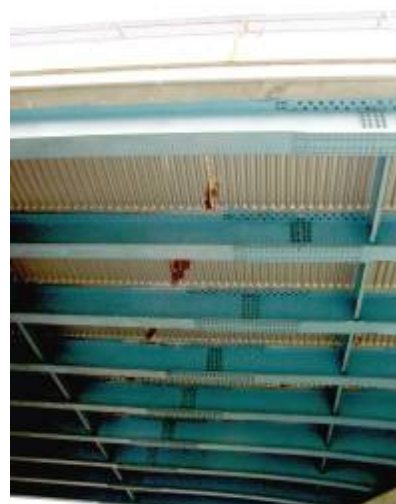
Figure 3.97. Corrosion at the SIPMF

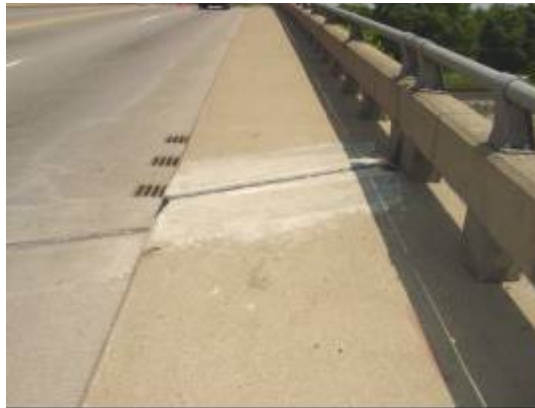
Figure 3.98. Different types of concrete around the joints

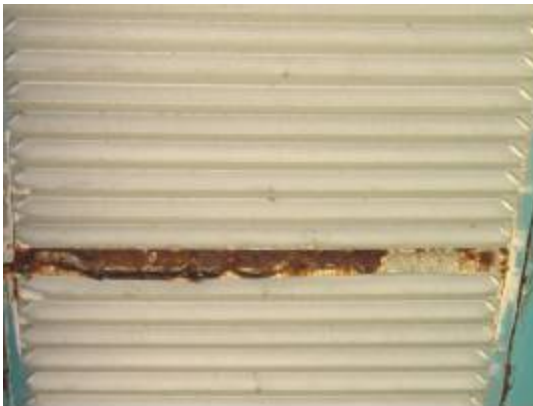
b. Corrosion in the SIPMF oriented transversely

Figure 3.99. Corrosion in the SIPMF is oriented diagonally and transversely

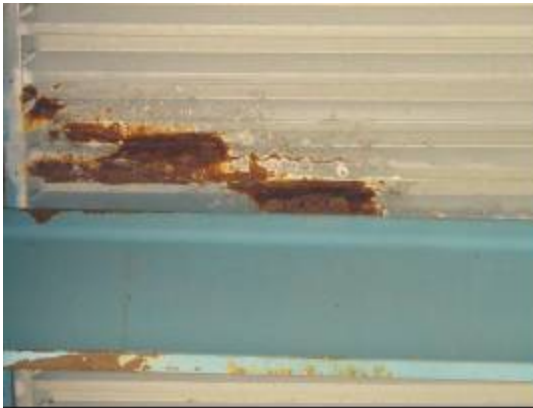
b. Corrosion in SIPMF near connection  
between main and bracing beams

Figure 3.100. Corrosion and white traces at the connection between SIPMF and steel beams

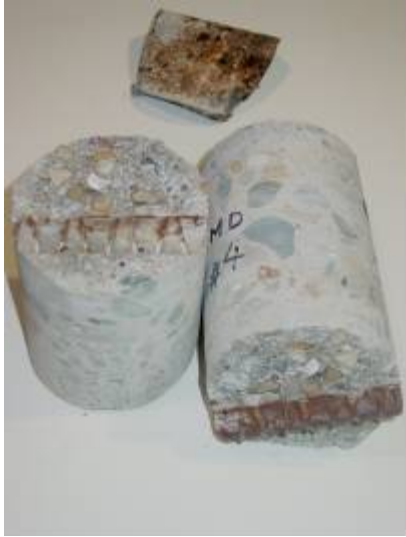
- 10.0 in. height.
- Lateral crack caused splitting at 4.5 in. from the top at the location of the reinforcement, which showed traces of corrosion.
- Four axial sections of reinforcement bars located 4.5 and 8.5 in. from the top.
- SIPMF separated from the core.
- The SIPMF left signs of rust on the surface of contact with the concrete.
- Reinforcement bars had rust traces.
- Four locations of honeycombing of average width of 0.3 in. were located 6.0, 7.5, 8.5 and 9.3 in. from the top.

Figure 3.106. Core 6d rust at the reinforcement bar

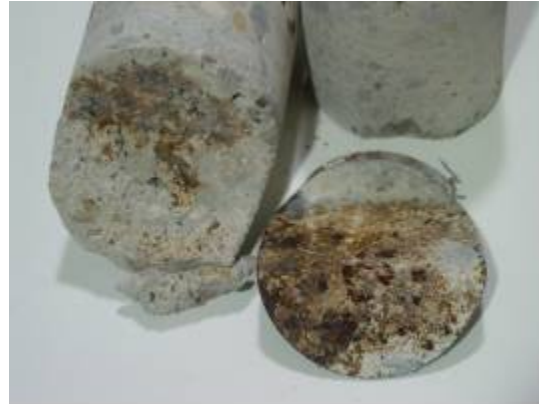
Figure 3.107. Core 6d rust on the SIPMF

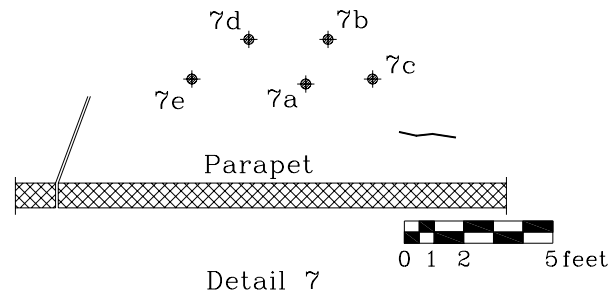
Figure 3.112. Map of cracks at coring locations for Bridge Deck Number 7 (Structure No. S03-81041)

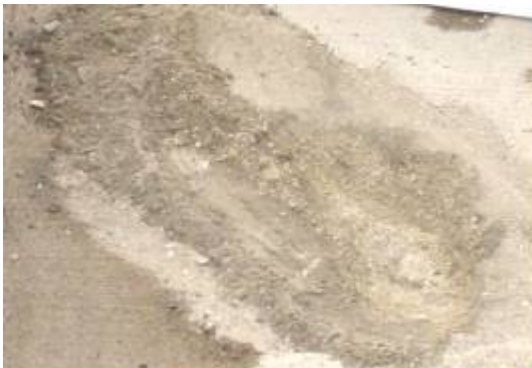
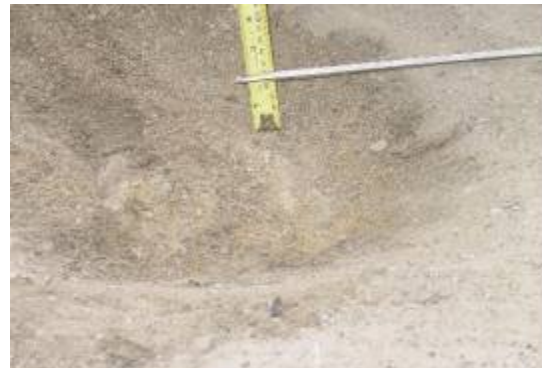
Figure 3.113. Deteriorated section in the deck slab

A deteriorated section of approximately 2 in. depth and 2 feet in diameter existed in the top surface of the bridge (Figure 3.113). In many locations along the bridge, the concrete curbs were deteriorated and the steel reinforcement bars were uncovered (Figure 3.114). The SIPMF was in good condition (Figure 3.115).

a. Large depression in bridge deck

b. Depth of large depression

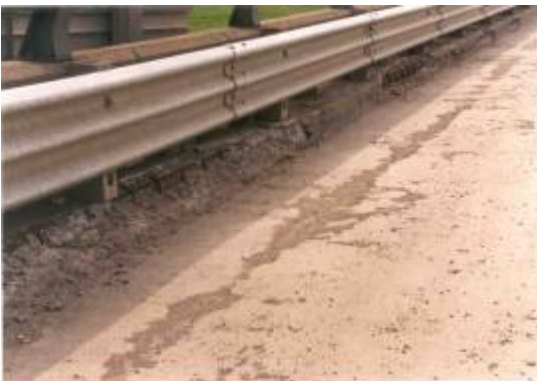
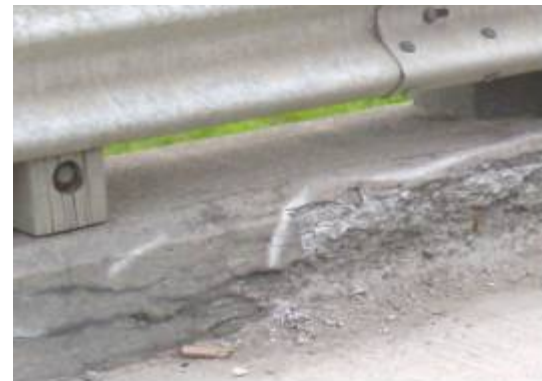
Figure 3.114. Severe deterioration on the curbs

a. Severe deterioration along the curb

b. Deteriorated section and white traces

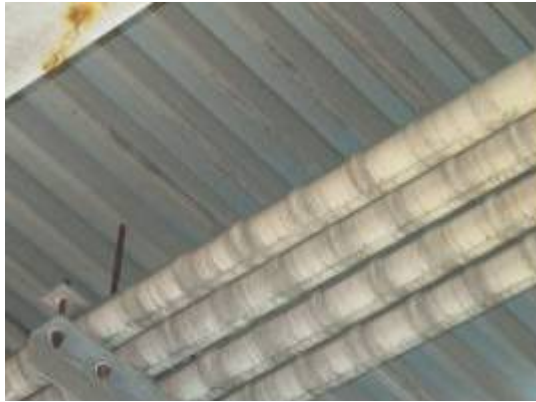
Figure 3.115. Good condition of SIPMF

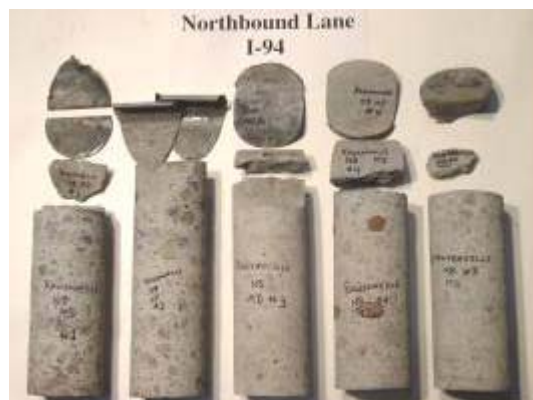
The visual inspection of cores from Bridge Number 7 indicated that the bridge had no separate wearing surface at the top surface. The steel reinforcement was not epoxy-coated and had traces of rust. The coarse aggregate was well bonded to the concrete. The cement paste had high porosity. Slag was used as aggregates in the deck slab. The SIPMFs for all of the cores were separated from the concrete (without leaving big traces adhering to its inner face). All of the cores had approximately the same height of average  $9.3 \pm 0.2$  in. (not including concrete placed in the valley of the corrugation of the SIPMF) which indicates bridge uniformity. The five cores are shown in Figure 3.116.

Figure 3.116. The 5 cores that were taken from Bridge Deck Number 7 (Structure No. S03-81041)

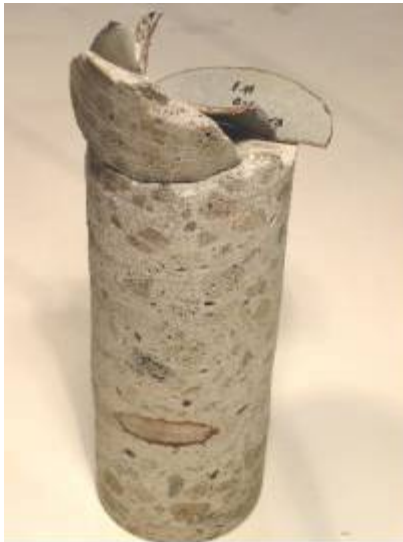
- 9.3 in. height.
- The concrete in the region of the valley of the SIPMF was broken during coring.
- Slag was used as aggregates in the deck slab; and cement paste had high porosity.
- One longitudinal cut in the steel reinforcement bar located 3.5 in. from top.
- Reinforcement bar had signs of rust.
- SIPMF was separated from the concrete and had 2 overlapping sections.

Figure 3.117. Core 7a is broken and reinforcement bar is rusted

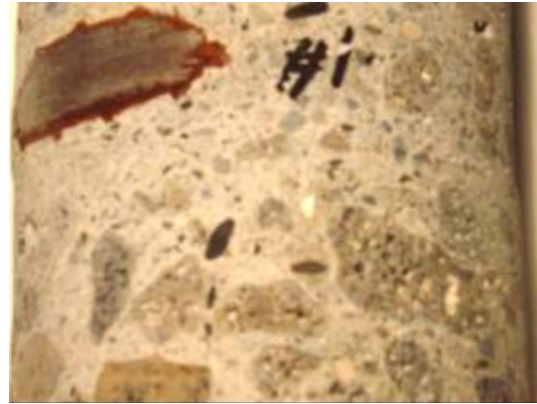
Figure 3.118. Core 7a reinforcement is rusted and concrete is porous

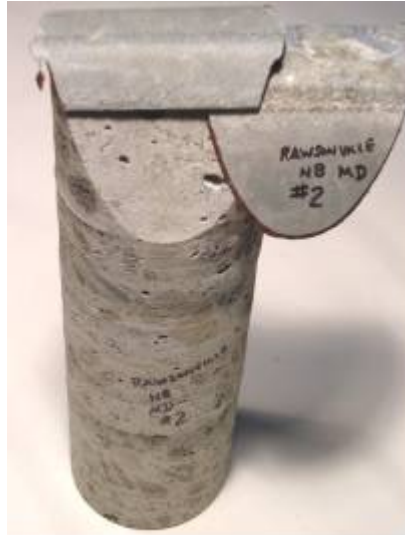
- 9.3 in. height (11.5 in. with the concrete in the region of the valley of the SIPMF).
- Large entrapped air voids of approximately 0.3 in. diameter occurred at the concrete in the region of the valley of the SIPMF at 0.8 and 1.5 in. from bottom.
- Four axial cuts in the steel reinforcement bars located 3.5, 3.8, 7.8, and 8.0 in. from top.
- SIPMF was separated with 2 overlapping sections.
- Slag was used as aggregates in the deck slab.

Figure 3.119. Core 7b shows large entrapped air voids and overlap of SIPMF sections

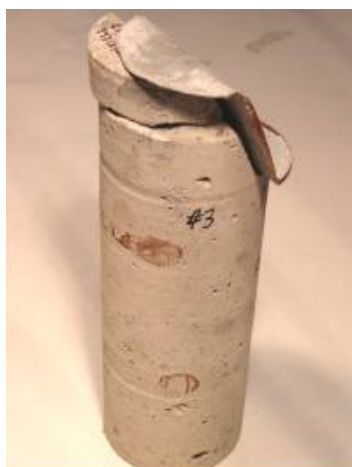
- 9.0 in. height (11.8 in. with the concrete in the region of the valley of the SIPMF).
- Slag was used as aggregates in the deck slab; and cement paste had high porosity.
- Many large voids of 0.3 in. average diameter.
- Two axial cuts in the steel reinforcement bars located 3.8 in. from top.
- One longitudinal reinforcement bar located 7.8 in. from top.
- Reinforcement bars had signs of rust.
- SIPMF separated from the core.
- Concrete in the region of the valley of the SIPMF was damaged during the coring.

Figure 3.120. Core 7c shows the broken concrete in the region of the valley of the SIPMF and the rust in the reinforcement bars

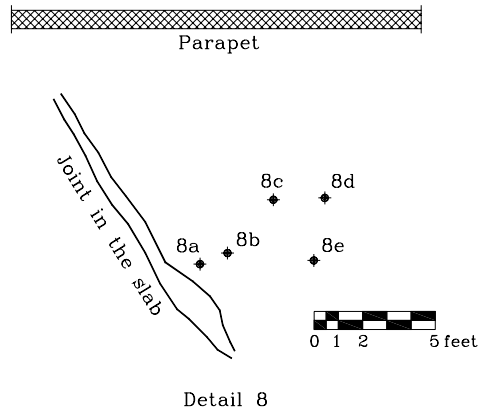
Figure 3.126. Map of cracks at coring locations for Bridge Deck Number 8 (Structure No. B01-82194)

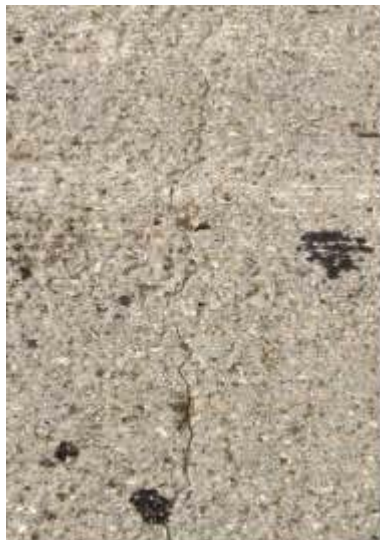
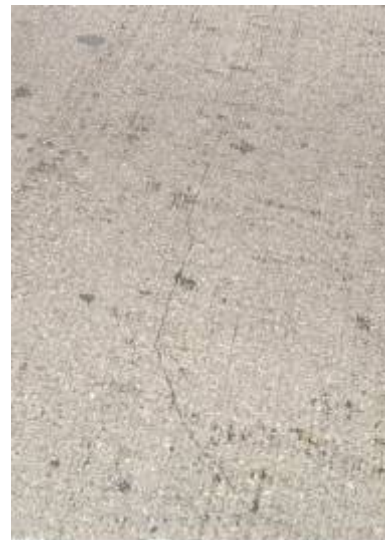
Figure 3.127. Top cracks propagated on the top surface of the slab

Cracks were found at the top surface of the concrete slabs. Cracks were propagated transversely and longitudinally (Figure 3.127). Deterioration was encountered in the joints between deck slabs (Figure 3.128). Wide regions of corrosion were found at the bottom surface of the SIPMF concrete placed in the valley of the corrugation of the SIPMFs (Figure 3.129). Traces of steel rust existed in the connections between the SIPMF and the steel girders (Figure 3.130).

a. Longitudinal Crack

b. Diagonal and transverse cracks

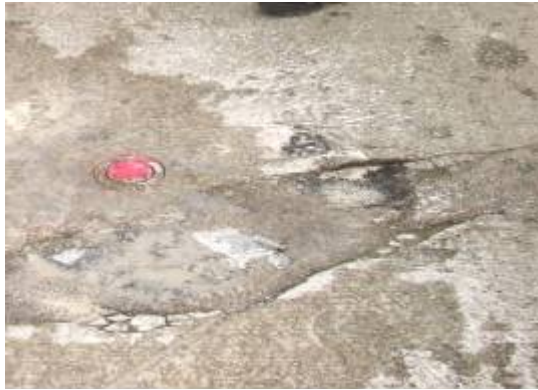
Figure 3.128. Deterioration in the joint

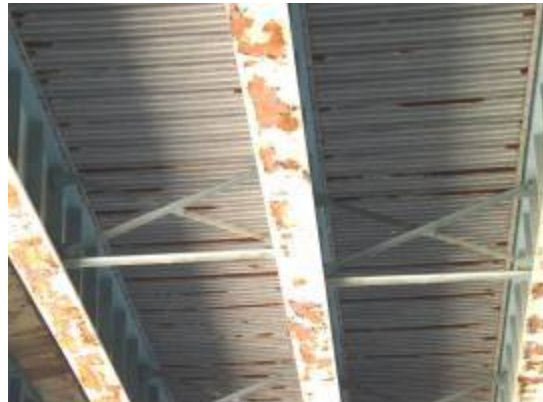
b. General view of the rusted SIPMFs

Figure 3.129. Corrosion in the SIPMF

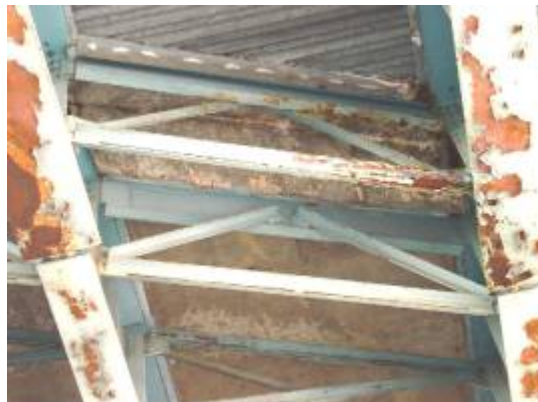
Figure 3.130. Rust in the connection between steel girders and SIPMFs

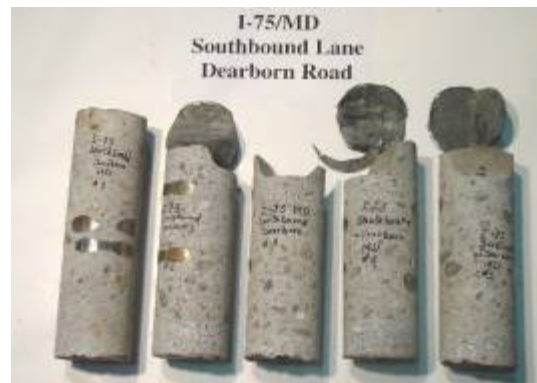
The visual inspection of the cores from Bridge Number 8 indicated that the bridge had a wearing surface of average 1.5 in. thickness at the top surface as shown by the different size of aggregates used. This wearing surface had a higher porosity than the rest of the core, and conventional aggregates were used for the wearing surface. Slag was used as aggregates in the remaining part of the core. The coarse aggregate was well bonded to the concrete. No regions of high porosity were observed. Many entrapped air voids were encountered and had an average diameter of 0.2 in. Many regions of honeycombing existed in all of the cores. The top surface was grooved for all of the cores. The steel reinforcement was not coated with epoxy. Some of the exposed reinforcement bars had rust traces while others were in good condition. The SIPMFs for all of the cores were separated from the concrete without leaving concrete traces adhering to its inner face. The height of the cores varied indicating non-uniformity of the bridge deck thickness. The five cores that were taken are shown in Figure 3.131.

Figure 3.131. The 5 cores that were taken from Bridge Deck Number 8 (Structure No. S03-81041)

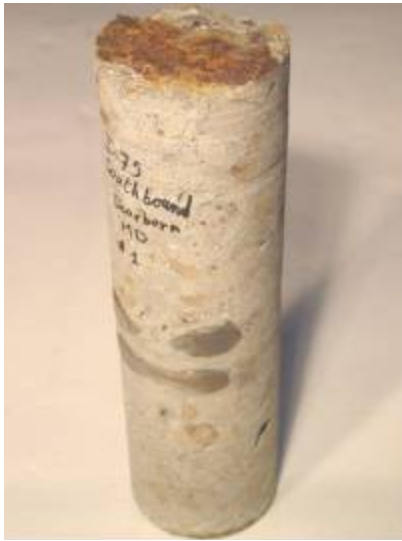
Figure 3.132. Core 8a

- 12.5 in. height.
- The concrete in the region of the valley of the SIPMF was broken during coring.
- Three longitudinal cuts through steel reinforcement bar located 5.5 and 6.5 in. from the top were observed.
- Two regions of honeycombing of average diameter 0.6 in. were observed at 3.5 and 9.5 in. from the top surface.
- One bar had minor rust traces while the others did not.
- The reinforcement bars were epoxy coated.
- SIPMF was separated from the concrete.
- The connection between the concrete and the bracing angle had traces of rust.
